UPGRADE AND INSTALLATION OF STORMWATER INFRASTRUCTURE ALONG DIVISIONAL RD. 1001, FROM KM 3.64 – KM 7.69, HANGKLIP, WESTERN CAPE

DEA&DP reference number: 16/3/3/1/B2/31/1009/19

Environmental Control Officer Monthly Report

Project name: Upgrade of existing degraded pip culverts at km4.08, km 5.31, km 7.07, and km 7.42, proposed installation of a new culvert at km 6.34, proposed installation of new sub-soil drains at km 6.36, 6.38, 6.40, 6.42 and 6.44 along divisional road 1001, Hangklip, Western Cape.

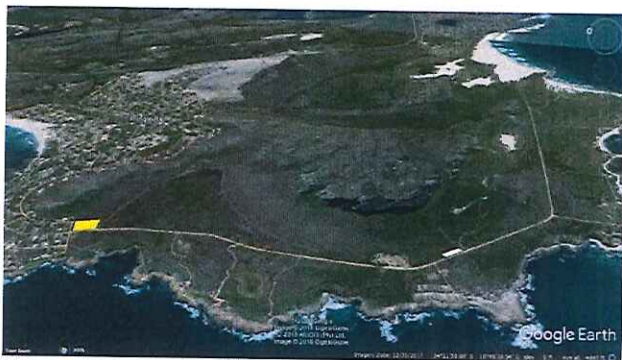
Figure 2: Refer to white block – approved site camp

The site camp is located on Portion 101 of Farm 559, Hangklip, Pringle Bay. The site was considered suitable for the following reasons:

- The site falls outside Critical Biodiversity Areas (CBA);
- The site falls within the previously disturbed and degraded road reserve;
- The site is highly infested with invasive vegetation and will be rehabilitated;
- Access to the site is existing; and
- The owner of the property as well as Overstrand Municipality and Overberg District Municipality gave consent.

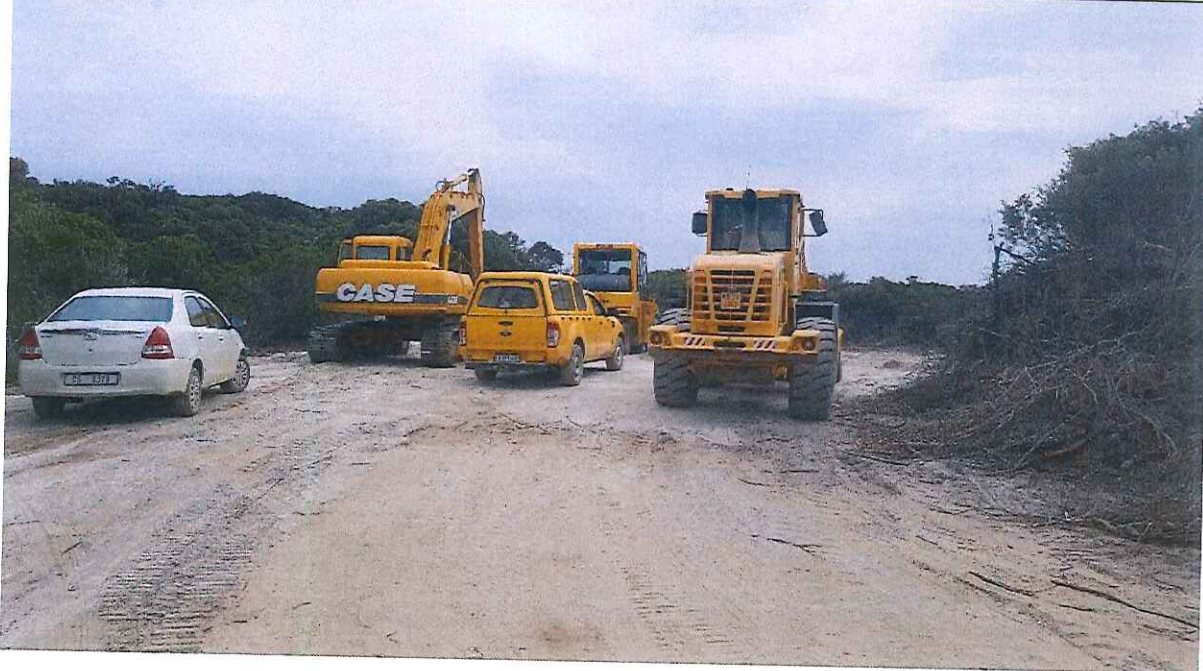
Figure 13: Construction site: Storage area for plant and equipment

- The storage area for the plant and equipment was not part of the Basic Assessment process but was necessary due to the limited space available at the stockpile site. Consent was obtained from the landowner. The site is heavily infested with *Acacia Cyclops*.

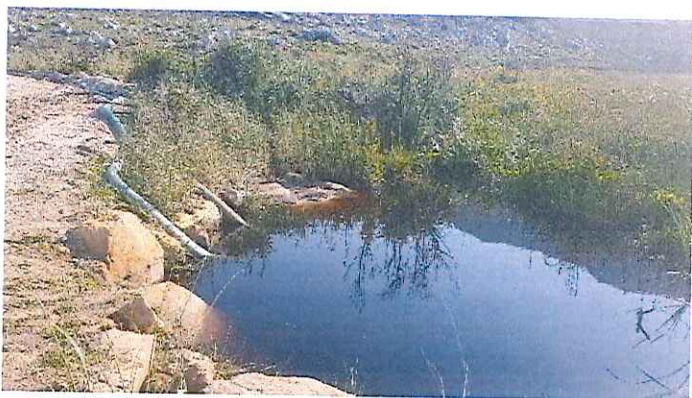
Figure 14: Water abstraction point

- Water abstraction is currently taking place at a point in the Buffels Rivier. This point has historically been used by the DPWT when doing maintenance on the gravel road. Alternative water sources are currently being investigated. The abstraction point is also monitored on a weekly basis to determine the impact.

- Weekly ECO monitoring inspections will be conducted for the duration of the project.
- An alternative water abstraction point needs to be investigated. Arrangements will be made between DPWT and Overstrand Municipality.
- Information signage should be placed at the construction site as prescribed in the EMPr.
- All grease spills should be cleaned in accordance with the relevant method statements.

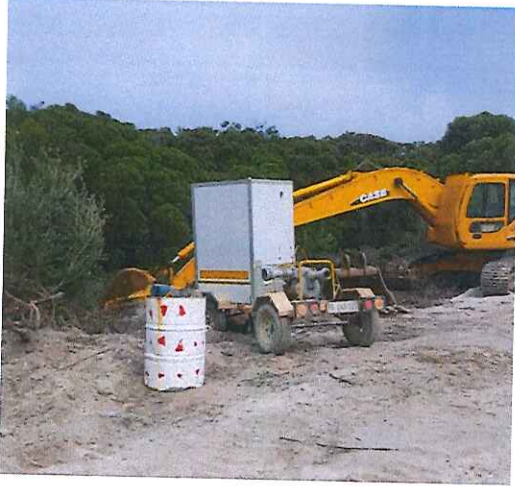
Figure 15: Ablution facilities and refuse bin.

An ablution facility was made available on site (Figure 15). Upon inspection several grease spills (Figure 16) were detected.
