UPGRADE AND INSTALLATION OF STORMWATER INFRASTRUCTURE ALONG DIVISIONAL RD. 1001, FROM KM 3.64 – KM 7.69, HANGKLIP, WESTERN CAPE

DEA&DP reference number: 16/3/3/1/B2/31/1009/19

Environmental Control Officer Monthly Report

This document serves as the monthly report for October 2019 and is the first ECO report for this project.

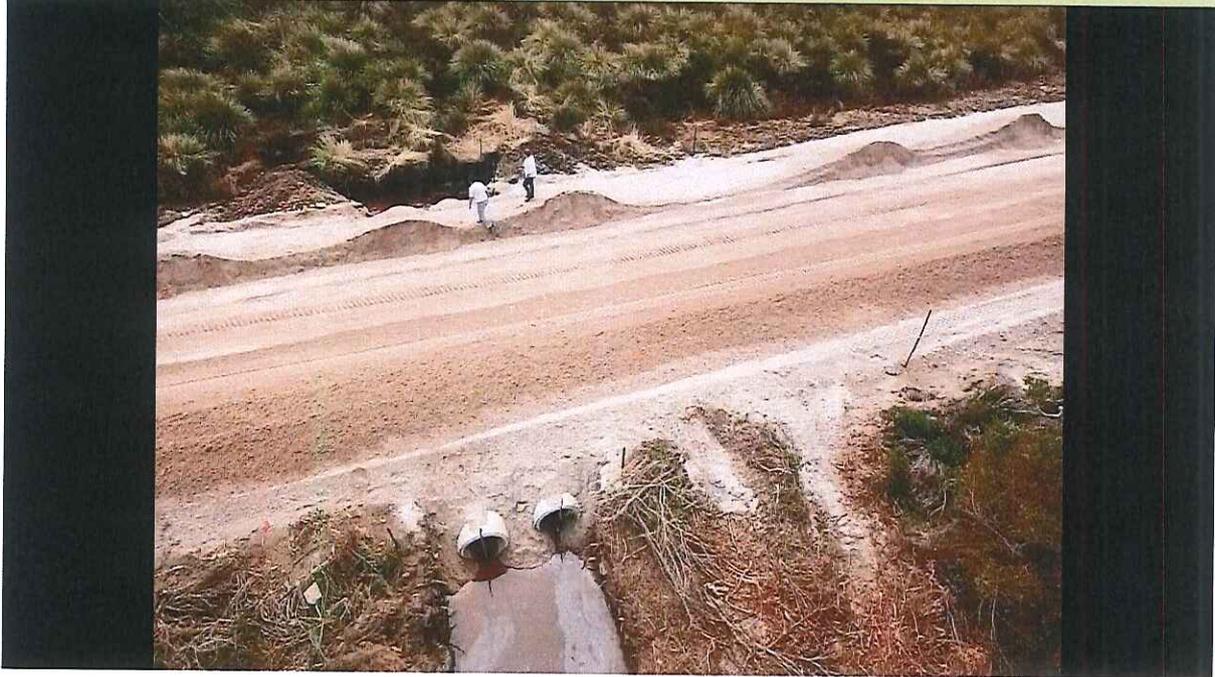
Figure 7: Construction site: Pipe-culvert at km 6.34

The pipe- culvert at km 6.34

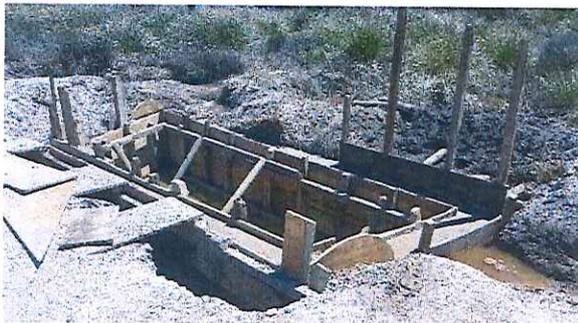
Figure 10: Construction of new culvert inlet

- Cement works have commenced at culvert km 6.34 for the construction of the box culverts and wing walls. It is important that cement works be done in strict adherence to the method statement for cement and concrete batching.

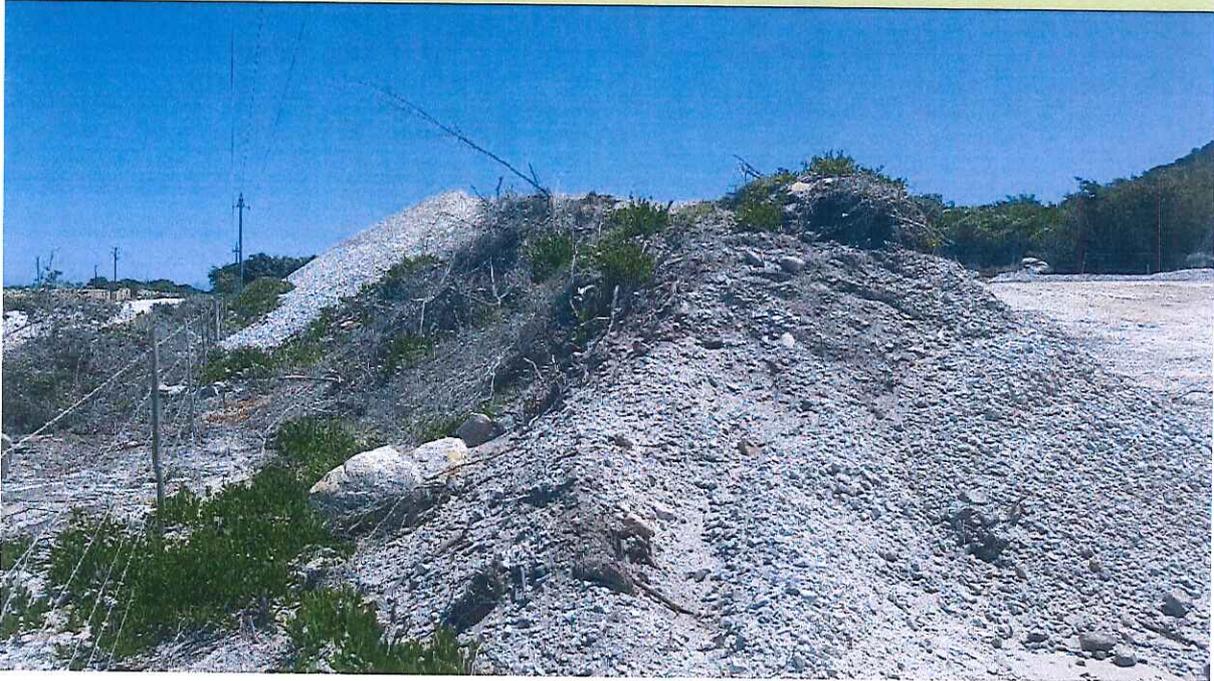
Figure 12: Construction site: Stockpile site

- Alien vegetation control needs to take place at the topsoil stockpile.

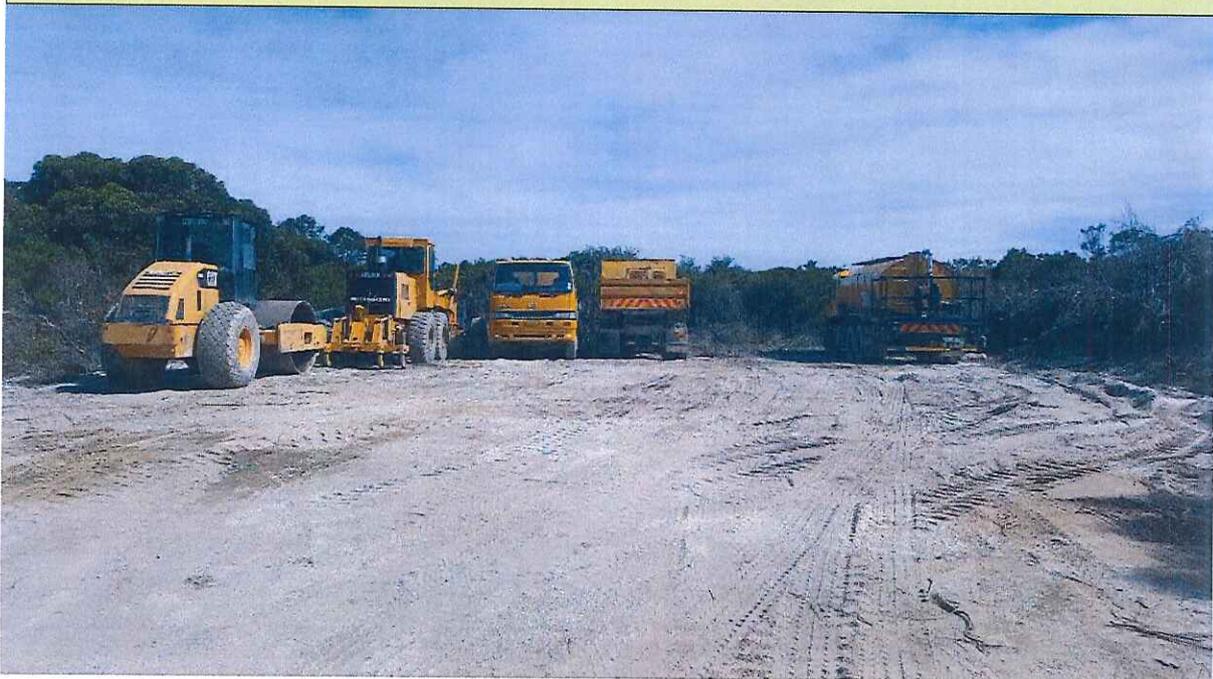
Figure 13: Construction site: Storage area for plant and equipment

- The storage area for the plant and equipment needs to be maintained. Oil cans on site need to be removed or stored in such a way as to not be a potential source of pollution.

The refuse bin needs to be closed and all grease and oil spills removed.

There are no drip trays on site.

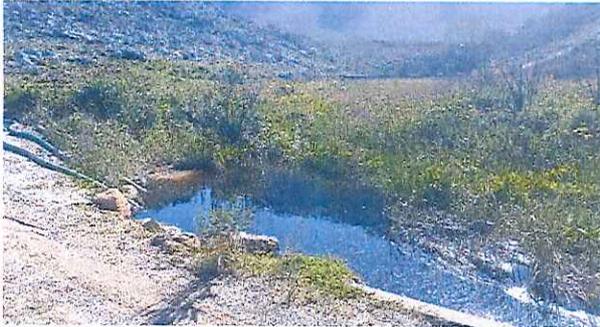
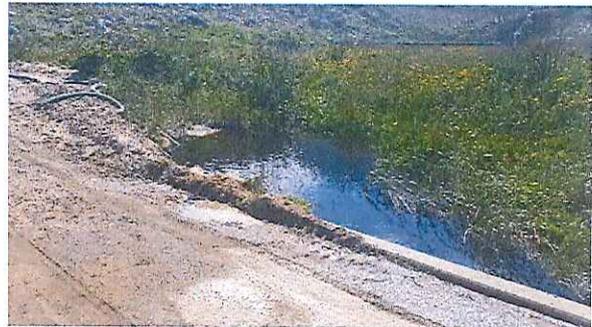
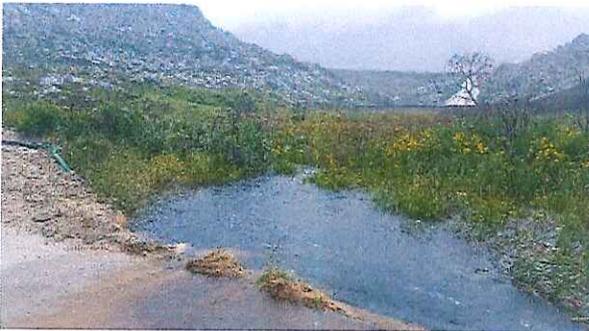
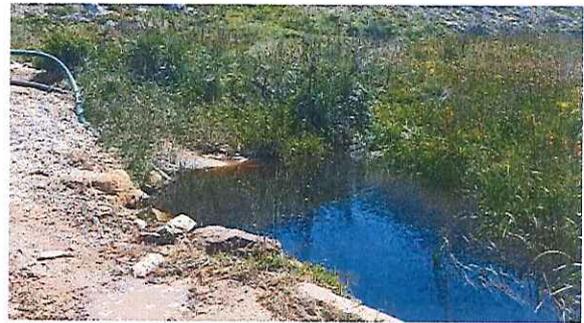
Figure 14: Water abstraction point – 03/10/2019

Figure 15: Water abstraction point – 18/10/2019

Figure 16: Water abstraction point – 25/10/2019

Figure 17: Water abstraction point – 31/10/2019

The site is monitored weekly. The water level at the site remain constant except for a flood event on 25 October 2019 where the water flowed over the road. Refer to figure 14 -17.

- The matter of the water abstraction point still needs to be resolved. A site meeting was held with the Breede/Gouritz Catchment Management Agency and Overstrand Municipality to discuss the matter.
